Coastal Management Report

Coastal Management at XXX Beach

Natural and Human Impacts

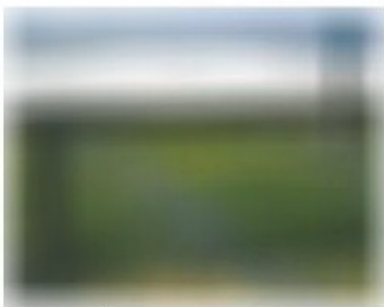
Figure 1.1.7

Fences have been put up around the dune restoration areas in order to protect them from humans (see figure 1.1.7). The vegetation on the fore dunes at the beach is very important as it holds the sand together, protecting it from erosion.

The use of fences to keep out both people and animals has worked very well for XXX Beach as it has protected the vegetation, allowing it to grow and preserve the sand. The preservation of the sand on the fore dunes has provided the beach with a natural reservoir of sand that it can use to deposit and take sand from. If this bank of sand was not there the beach would slowly begin lose its sand as the effect of the destructive waves would damage the beach and have no way of replenishing itself on its own. It has been effective as the vegetation has been able to grow (see figure 1.2.2) and hasn't been destroyed by the community.

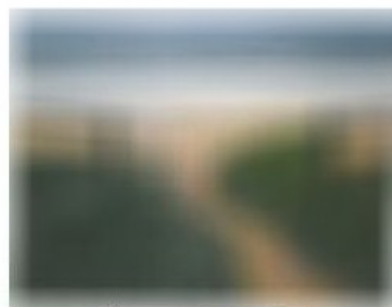
Figure 1.1.9

Designated Pathways have been created from the picnic area to the beach to ensure the safe and less damaging exit and entrance onto the beach (see figure 1.1.9). They are placed along the beach so that the public don't walk through the dune restoration area, which assists with the preservation of the natural vegetation and pleases the public as they don't have to walk through it.

The designated pathways situated along the beach have outlined specific areas that the public should use to access the beach, allowing the fenced off areas to protect the vegetated dunes. If people were to walk all over the vegetation it wouldn't have been able to grow properly, therefore leaving the dunes unprotected. They also only allocate a small section of the dunes for people to walk all over, resulting in less sand being eroded. These pathways have been effective as they have also protected the vegetation on the dune and have given the community a safe way to access the beach.

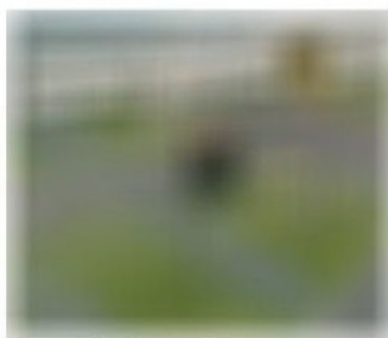
Figure 1.2.1

The amount of litter that is dumped on the beach is minimised due to the placement of bins near the car park (see figure 1.2.1). The public is encouraged to throw their rubbish away as there are bins in the picnic area, leaving less litter on the floor.

The installation of bins along the picnic area has helped keep the beach tidy but it hasn't kept it completely clean. Although the bins encourage people to put their rubbish in the bins, the distance from the beach to the bins is quite far, which sometimes makes people take the easier option of having it on the beach. This strategy isn't quite as effective as the other three but with small changes it has the ability to become more effective.

Improvement 2: The idea to place bins along the picnic area was useful for the community as when they come down to the beach and have a picnic they need somewhere to dispose their rubbish. The main negative point about this idea is that the bins are quite far away from the actual beach. The distance between the bin and the beach is quite far and can mean the difference between rubbish being disposed of properly and being dropped on the floor. To fix this problem bins should be situated along the fence separating the beach from the picnic area, and a bin at the end of each designated pathway to ensure that whether food is consumed on the beach or in the picnic area there will be bins close enough to encourage the proper disposal of rubbish.

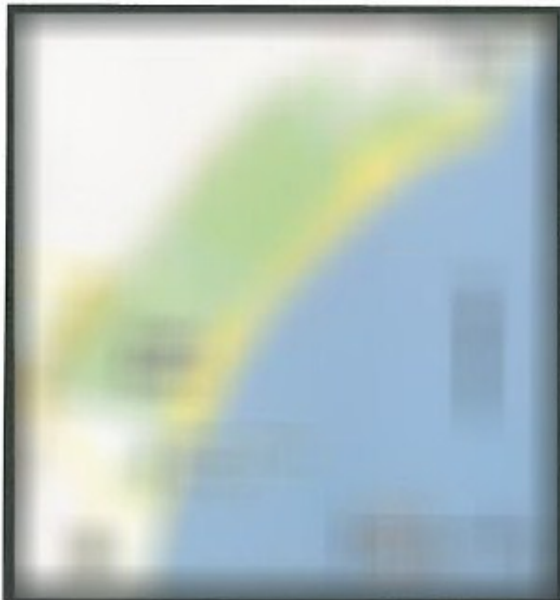
Map of [redacted] Beach showing the Zoning Areas for New Development

Strategy 3: To help the vegetation and fore dunes rejuvenate over time, the use of zoning could keep developers from building too close to the beach and stay away from the fore dune areas. Although it may not seem so important now, as time progresses the coast will continue to erode, therefore it is important to start mapping out areas that should not be allowed to have development. If new development begins at least 500m from the coast it would allow the natural dunes to rebuild themselves (see figure 1.2.3). The existing development will not need to move but this should be applied to all new development ideas.
